Degradation of Power Contacts in Industrial Atmosphere: Silver Corrosion and Whiskers

Bella H. Chudnovsky
Square D Company
West Chester, OH 45069, USA

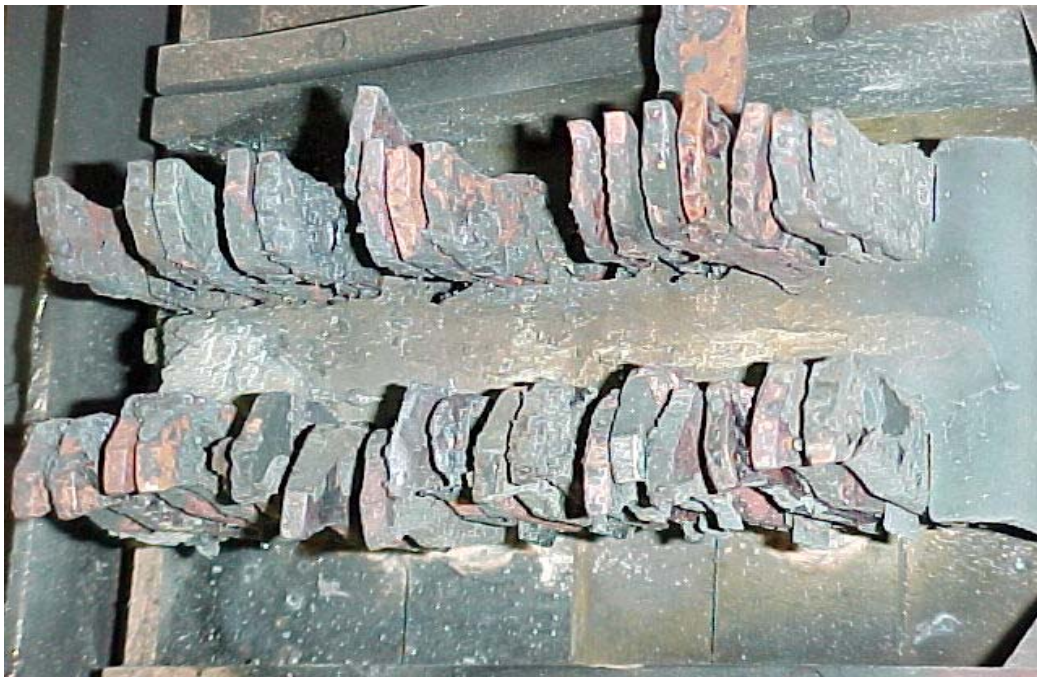
Fig.2. Finger Cluster after failure in July 2000

Since then every 2-3 months the electric service group at the plant performed cleaning of the units subjected to extensive corrosion and whiskers' growth (Fig. 1). Two units, which have been thoroughly cleaned in May 2000, failed in July 2000 just two month after previous maintenance (Fig. 2).

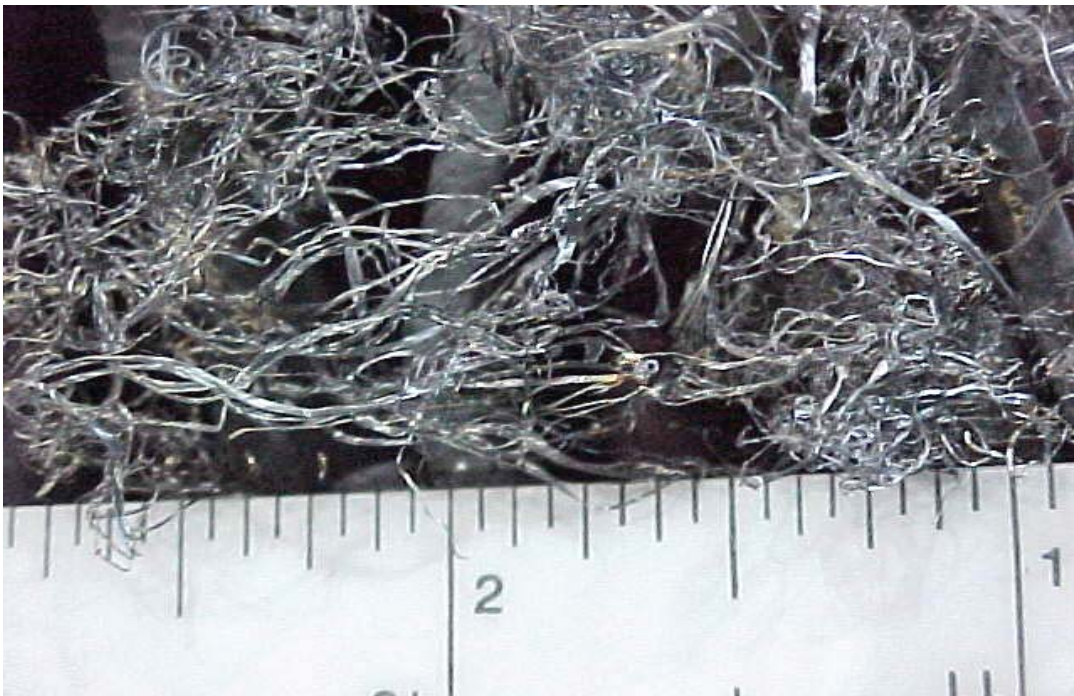
Fig. 4. Clump of two-month old silver whiskers

ranging from tiny thin “dawn”-looking formations to thick and strong threads, which are bound together into large tufts and clumps (Figs. 3, 4).

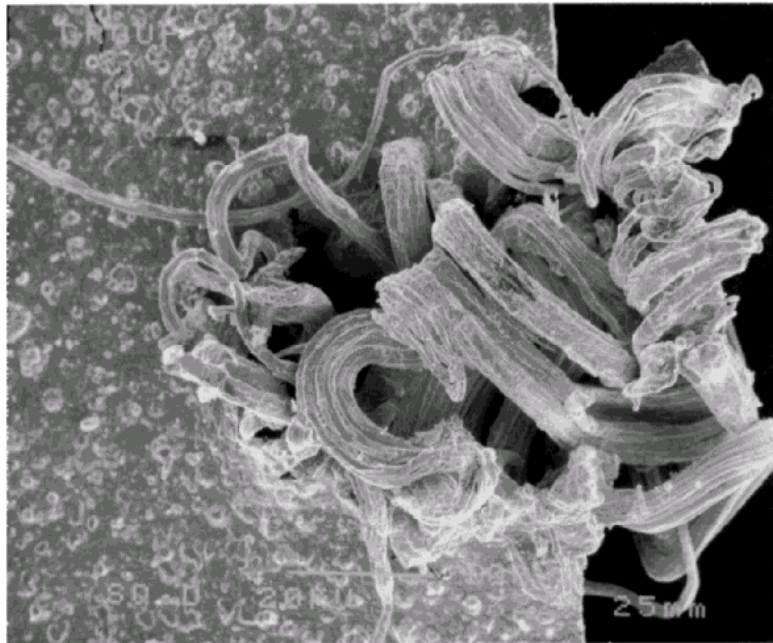
Fig. 6. Newborn silver whiskers, x350

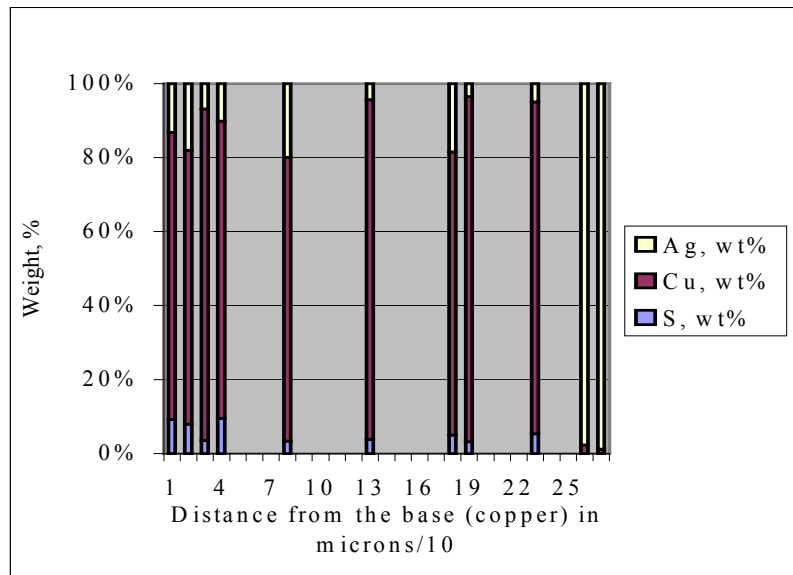
Fig. 14. Atomic profile of the sample with silver whisker growing from corrosion layer (Fig.13)

Silver content changes across the border between corrosion layer and whisker drastically from ~3% in corrosion layer to 100% in whisker's body (see graph in Fig.14).
